PROJECT: DIPECHO – VI «Fostering Disaster-Resilient Communities in Isolated Mountain Environments of Tajikistan and Kyrgyzstan»

«Outcomes of risk assessment from natural disasters, evaluation of fire safety and earthquake resistance at educational institutions in Chong-Alai rayon of Osh oblast, Kyrgyz Republic»

BISHKEK-OSH– 2011

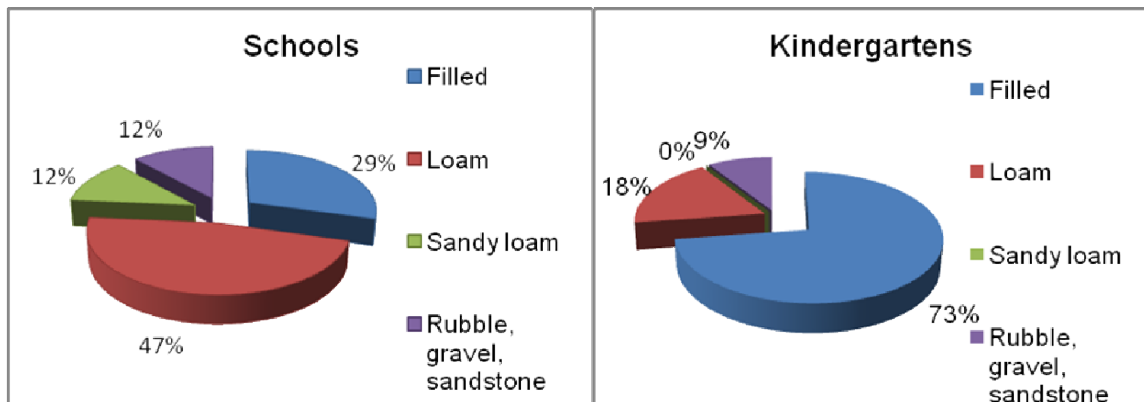
Picture 3. Correlation of first layer soil types

As it reads from Table III.1 and Charts in Picture 3, the majority of bedding soils with layer thickness of more than 100 cm are loams and filled soil; in two schools these soils

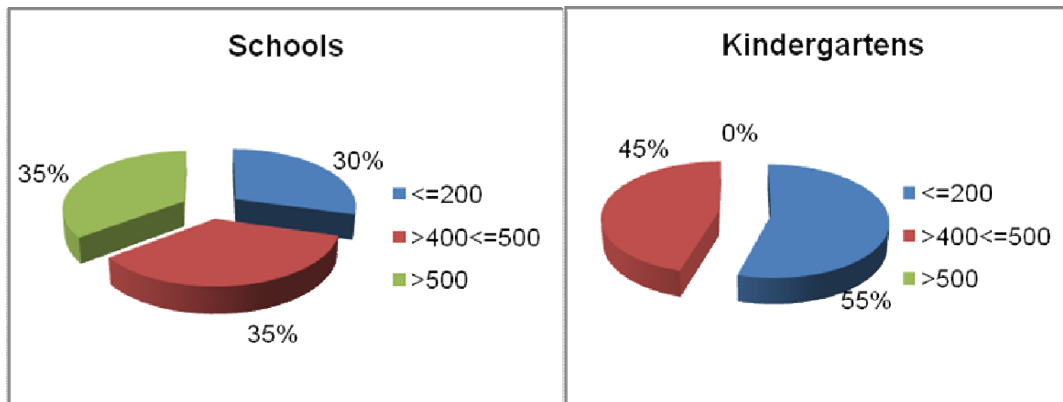
Picture 4. Estimate resistance of carrier layer

Table III.2. and Picture 4 shows that the main estimate resistance of carrier level in institutions is as follows: less than 200 kPa and between from 400-500 kPa. Only 6 schools have soils with more than 500 kPa resistance capacity. When designing a carrier resistance of a building, in particularly social facilities, deformational and bond properties of soil should be considered. This is because the heterogeneous or weak foundation soils (where estimate resistance indicators of carrier level are close to null) may lead to unacceptable deformations of buildings, which may then be found in emergency condition.

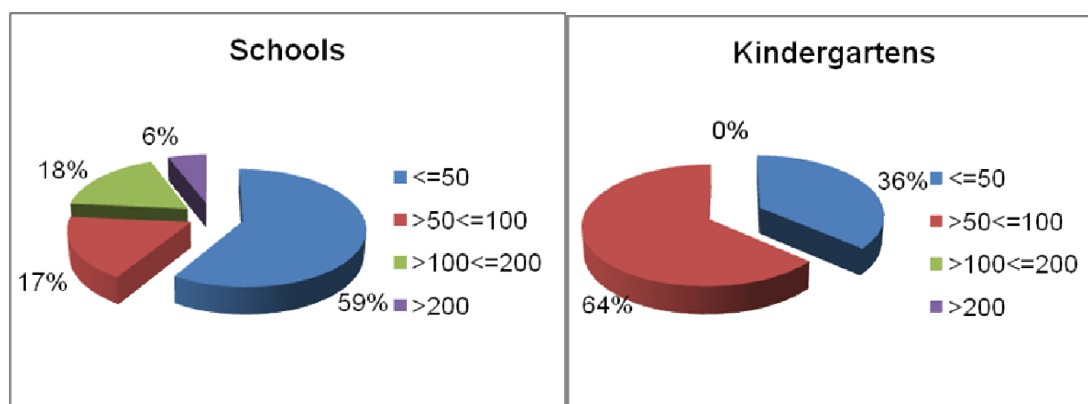
Picture 5. Correlation of foundation depth

Table III.3 and Picture 5 show that the foundation depth of the majority of institutions, i.e. 59% of school foundations and 36% of kindergarten foundations is placed for less than 50 cm. According to SNiP KR 20-02:2009²⁷, chapter 6.2, item 6.2.2 “Depth of foundation should be at least 10% of the height of upper (surface) part of the building and should be at least 1 m”.

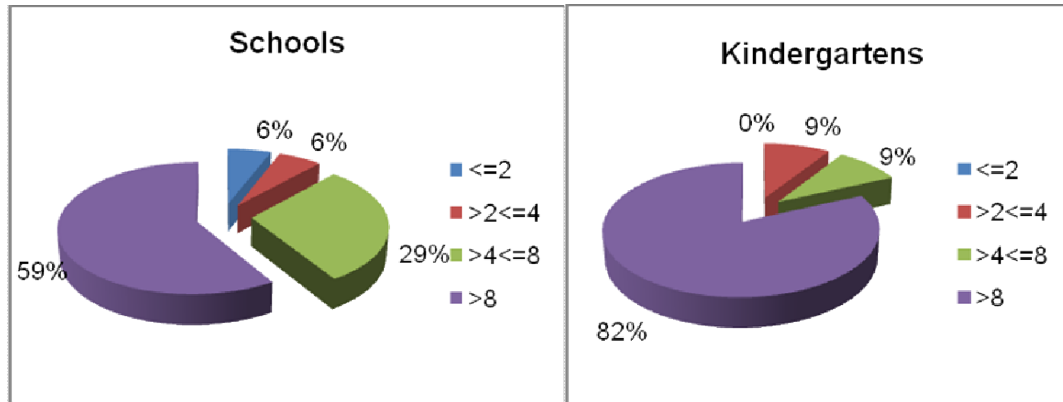
Picture 6. Ground water level (GWL)

The subject rayon is a high mountainous area with maximum depth of zero isotherm penetration of more than 2 meters at all locations. This explains that in case of rise of GWL in this severe climate and in view of shallow foundation depth it may lead to frost heaving everywhere. However, this is a very widespread process, firstly because of deep levels of ground water. The pie chart at Picture 6 shows that the GWL at almost all facilities is more than 8 meters.

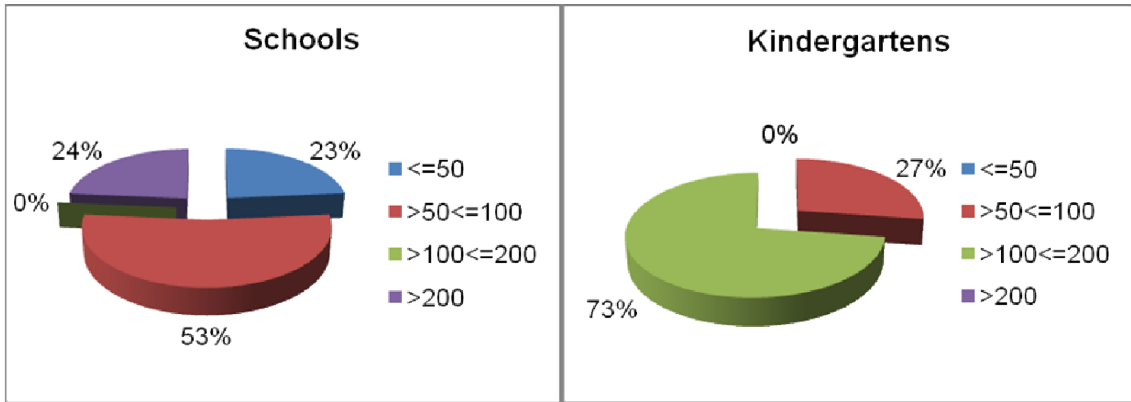
Picture 7. Indicators of foundation height

During the inspection of general foundation heights, the situation from point of building codes seems normal. 56% of schools and 27% of kindergartens have 1-meter high foundations. However, if we consider that the rayon territory has sufficient gradients in many locations because of a high mountainous region, and consider that the survey took into consideration the average height of foundations, it will be clear that the foundation height above the land surface is also not very high. This fact may reduce the age of walls of the structures.

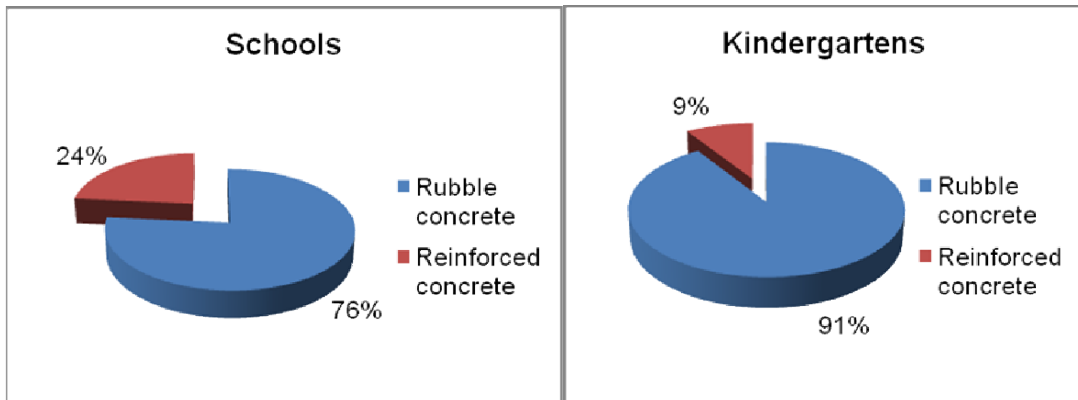
Picture 8. Foundation material

The majority of foundations have been built of rubble concrete - 76% of schools and 91% of kindergartens. According to SNiP KR 20-02:2009⁶ constructing buildings with rubble concrete foundations in such seismically active regions is not advisable.
