Case Studies of **Seismic Nonstructural** Retrofitting in

School Facilities

December 2005

Educational Facilities Research Center, National Institute for Educational Policy Research,  
Study Group Report on the "Investigative Research for Promoting the Seismic  
Retrofitting of School Facilities"

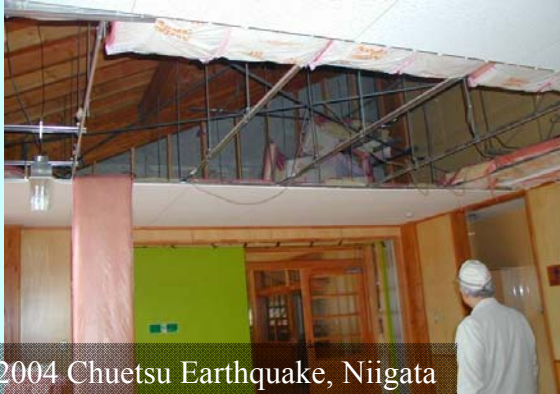
2004 Chuetsu Earthquake, Niigata

- Falling ceiling materials at the special classroom
  - Ceiling boards fell together with the mounting brackets because of significant seismic motion.

- Daily inspection
  - Verify that tie braces are installed by inspecting through access ports.
  - Verify that intervals between hanging bolts are sufficient and that the bolts are tightened.
  - Verify that ceiling board have not moved, cracked or deformed, and that fasteners are not loose or rusted.
- Retrofitting
  - Provide sufficient space between ceiling material and wall or column.
  - Hanging bolts are long ( $\geq 1500$  mm) in gymnasiums where there are significant space between the roof and ceiling). Horizontal and diagonal tie braces should be installed to prevent the ceiling from moving.

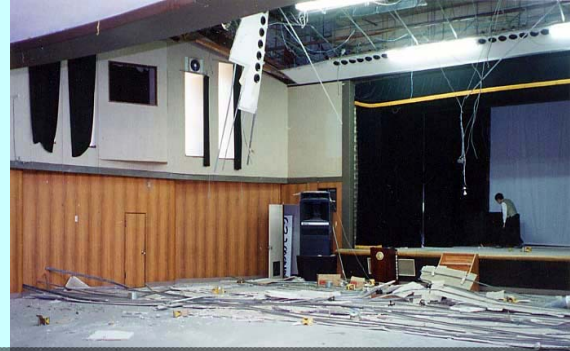
1993 Hokkaido Southwest Offshore Earthquake

- Fallen auditorium ceiling
  - Auditorium ceiling material fell together with the mounting brackets because of significant seismic motion.

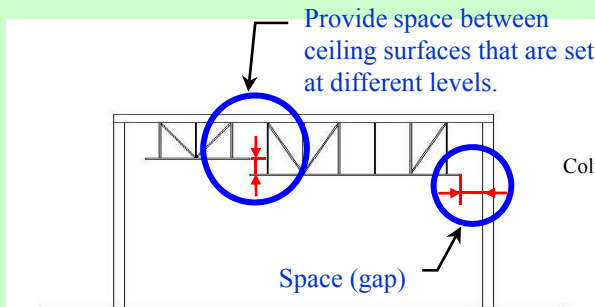
#### Ceiling surfaces that are uneven or set at different levels

- Ceiling surfaces set at different levels
  - This results in some portions of ceilings with high or low rigidity, which requires retrofitting, such as by securing space between portions with different rigidity.

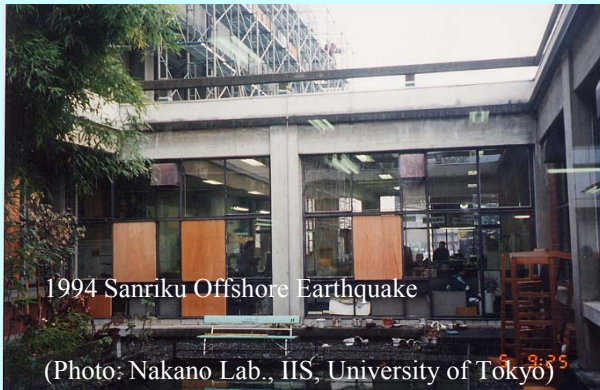
- Damages attributed to the windowpane installation method
  - Fixed windows were damaged, when installed with hard sealants according to the previous method in use before the current provision\*, and the windowpanes could not follow structural deformation.
  - When wire-reinforced glass is cracked, it does not fall, but normal sheet glass becomes shattered and fall.

- Prevent sidings from falling
  - Apply antishattering film on normal sheet glass, to make it act like wire-reinforced glass, and prevent the glass from shattering and falling.
  - Inspect that there are no degradation or loosening of fixtures. Adjust fixtures if necessary.
- Allow deformation of adjacent members
  - Stop using hard sealants to fix sheet glass to the window frame. Install windowpanes in accordance to the current design provision\*.
  - Use bracing connections that prevent buckling of tie braces in the lateral direction (Right photo).

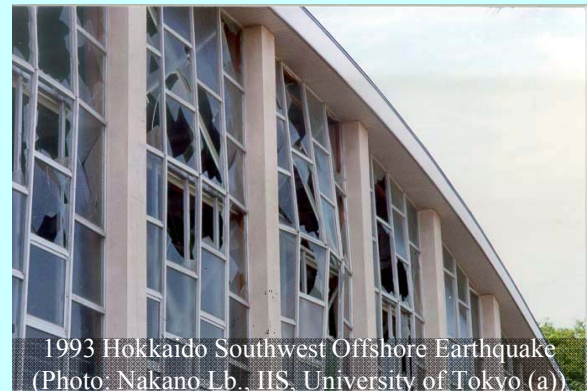
- Damaged windowpane hit by braces.
  - Buckled bracing members at the gymnasium protruded in the lateral direction, hit the windowpane, and broke the glass (Photo a).

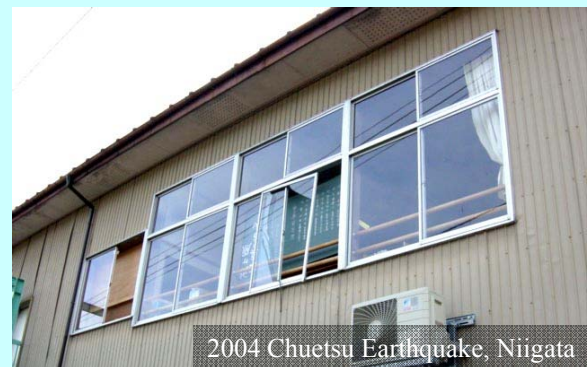
### ■ Derailed windows and doors

- The earthquake impact derailed the fixtures and broke windowpanes.

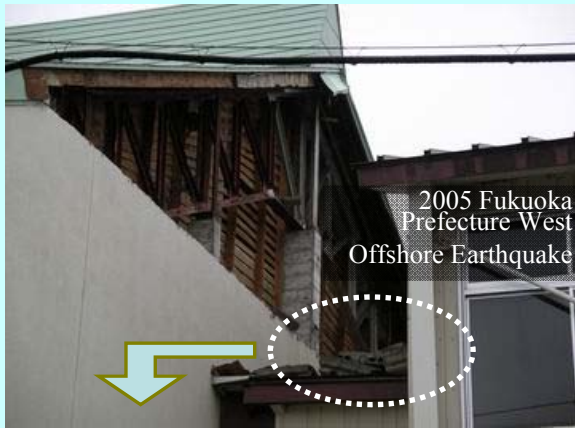
- Staircase roof was directly hit by block sidings that collapsed from the gymnasium gable wall.

- Repair spalling and cracked sidings by injecting resin, replacing fasteners, reinforcing to prevent collapse, or refurbish with other building methods. (If immediate implementation is difficult, apply emergency measures, such as by restricting entrance or passage by considering the potential area affected by falling material.)

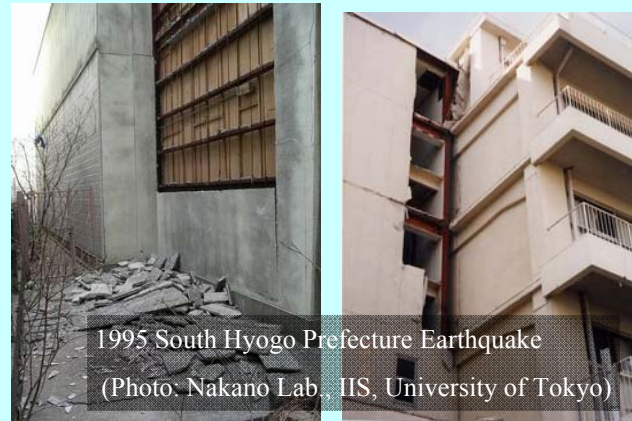
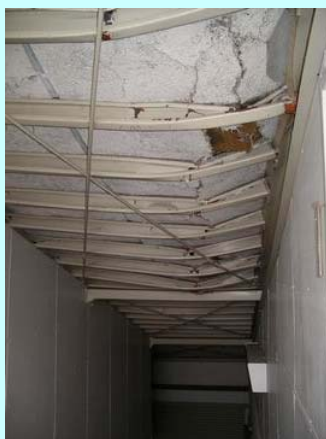
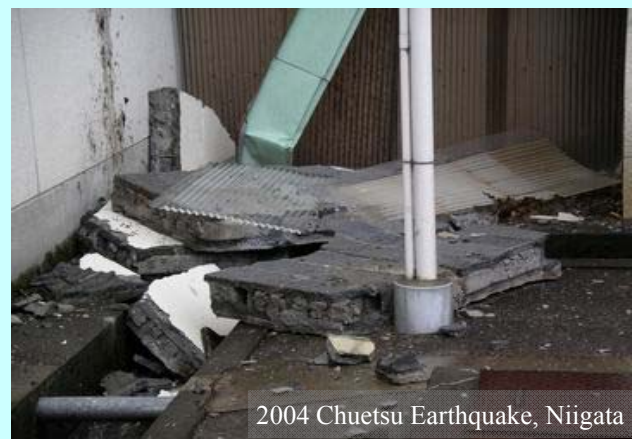
#### ■ Collapsed ALC\* and precast panel sidings

- Exterior sidings was damaged and had fallen, when they could not follow the seismic deformation, or when they collided with adjacent structures (main structures were steel in both cases).

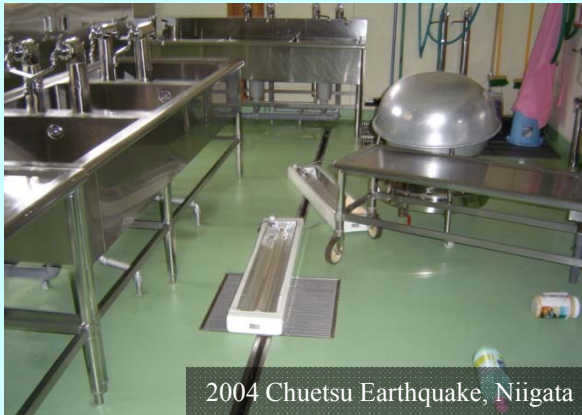
- Lamps fell to the floor together with mounting brackets (chain pendant type).

- Verify that lamp mounting brackets are not loose.
- Verify that there is no rust or deterioration of mounting brackets.
- Verify that lamp shades are not left loose.

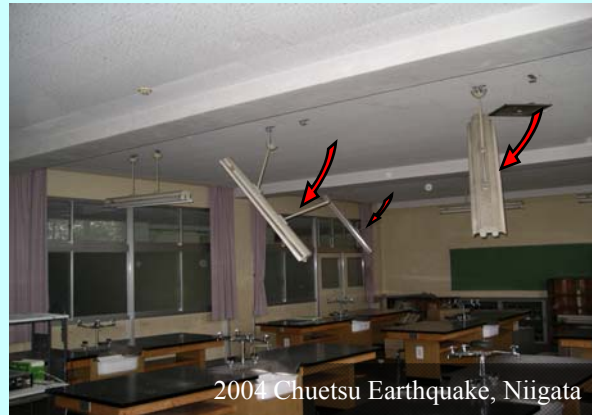
■ Fallen lighting fixture (pipe hung type)

- Lamps were left dangling when mounting brackets in the ceiling failed.

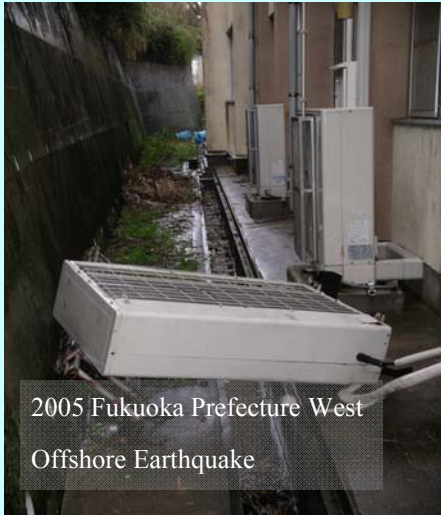
#### ■ Overturned air conditioner outdoor unit

- The outdoor unit overturned when the mounting fixture failed during the seismic impact.

- Verify that there is no rust or deterioration of mounting fixtures.
- Verify that mounting fixtures are intact and sufficiently anchored to the base.

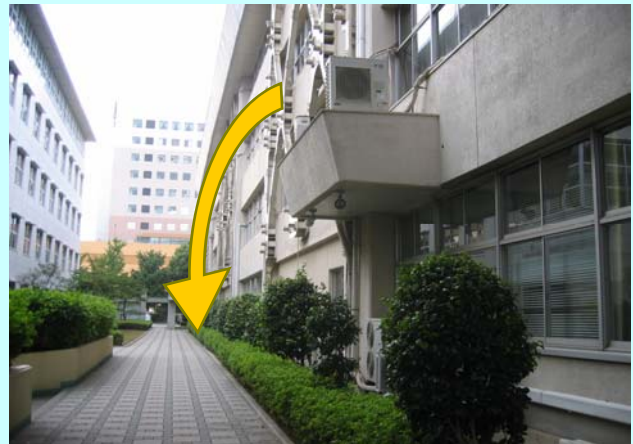
#### ■ Dangers of placing outdoor units on eaves and roofs.

- Falling air conditioner outdoor units that are installed on roofs and balconies could harm pedestrians.

- Sufficient care is needed for installing air conditioner outdoor units on roofs and balconies at the second floor and above, since they could fall from the seismic impact and harm pedestrians.

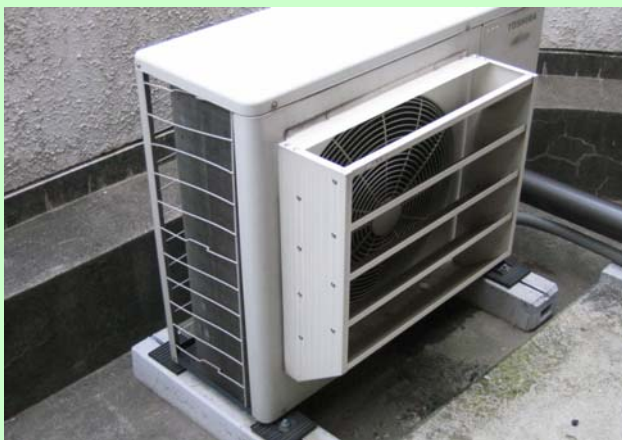
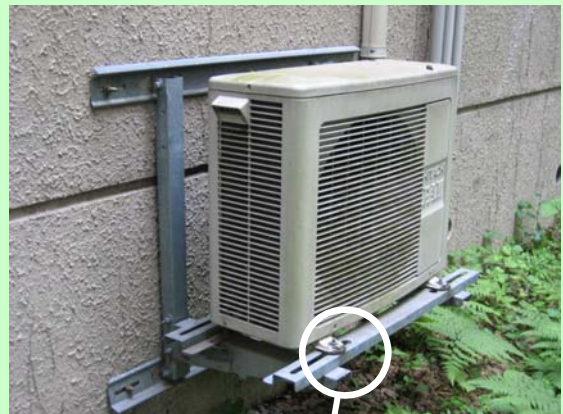
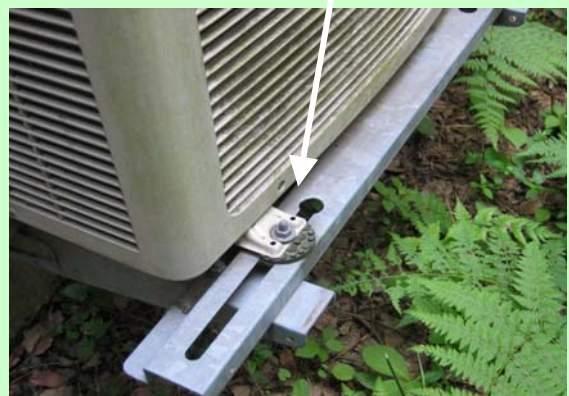
- Install restrainer to prevent uplift of outdoor units (See right photo).

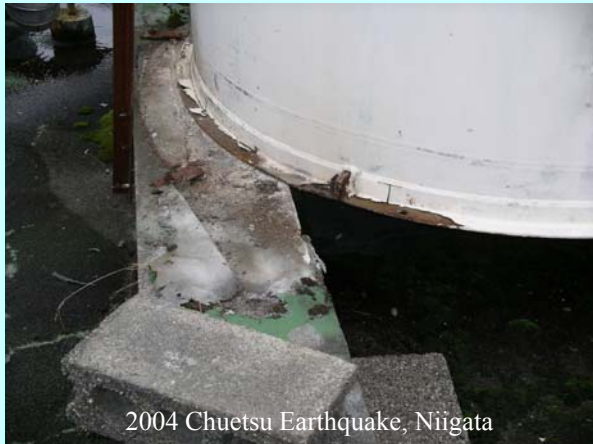
2004 Chuetsu Earthquake, Niigata

- Insufficient anchoring of elevated tanks and cooling towers result in shifting and displacement from the impact of the seismic motion.

- Verify that there is no rust, deterioration or loosening of anchor bolts or uplift restrainers.
- Verify that there are no defects or damages on the concrete base where anchors or uplift restrainers are fixed.
- To continue the use of items from immediately after the earthquake, verify that the pipe connectors use flexible joints.

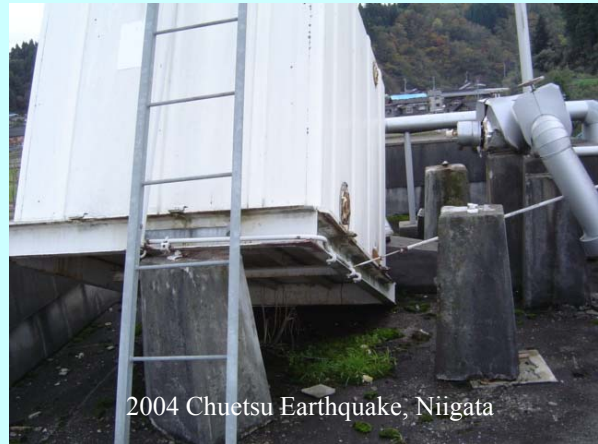
■ Shifting and displacement on concrete base.

- Seismic motion shifted the elevated water tank, which fell off the base.
- The seismic motion shifted and overturned the concrete base itself.

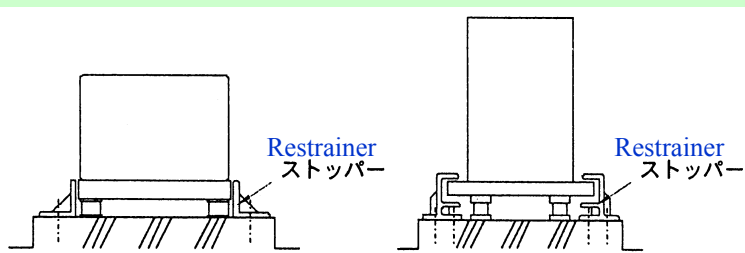
For a unit with relatively low center of gravity, a retractor that could restrain horizontal displacements is sufficient.

For units with high center of gravity, it is advisable to use restrainers that could restrain horizontal displacement and uplift.

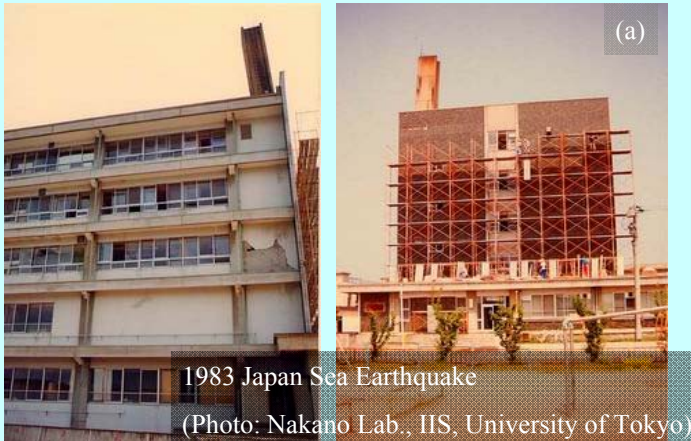
#### ■ Damage on reinforced concrete outdoor chimney

- Damage at the base of reinforced concrete chimney positioned above the roof (See photo a)
- Fallen chimneys that had stood along the school building.

- For concrete chimneys, verify that there are no degradations, such as cracks, detachment or spalling of surface mortar, rusting rebars, and deterioration.
- For metal chimneys, verify that there are no rusting or degraded fixing brackets, loose fixing wires, or moving chimneys.
- Inspect that old or unused chimneys are not left remaining in school.

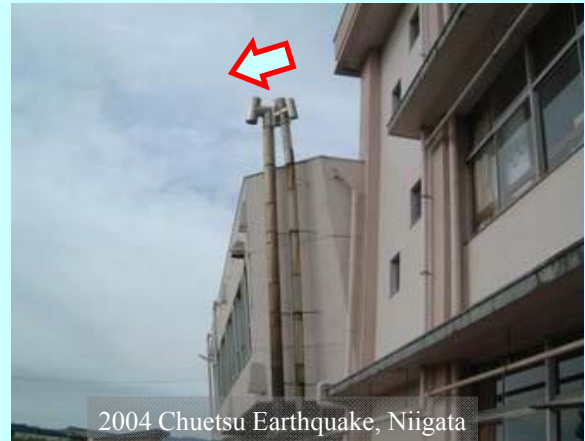
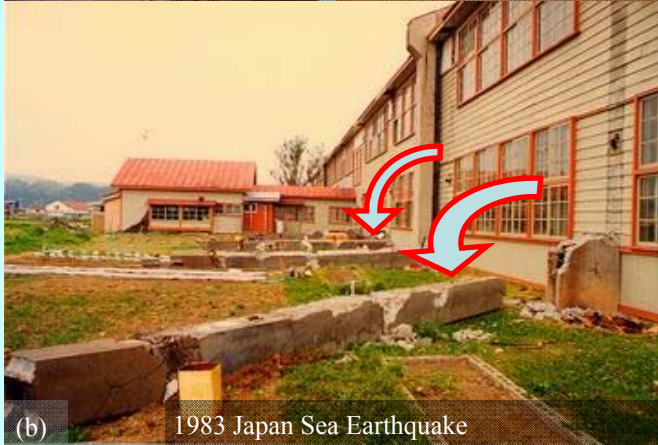
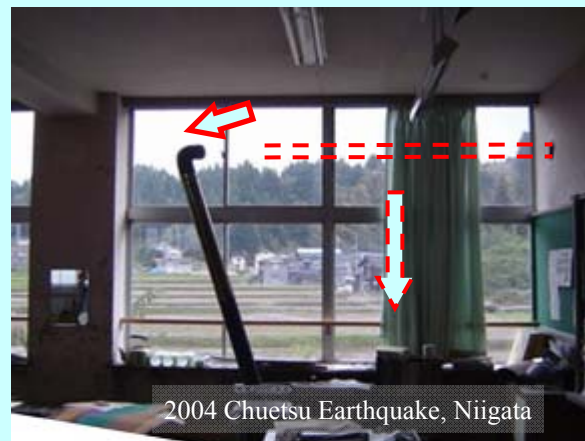
#### ■ Tilted metal chimney

- The top of indoor and outdoor metal chimneys have tilted.

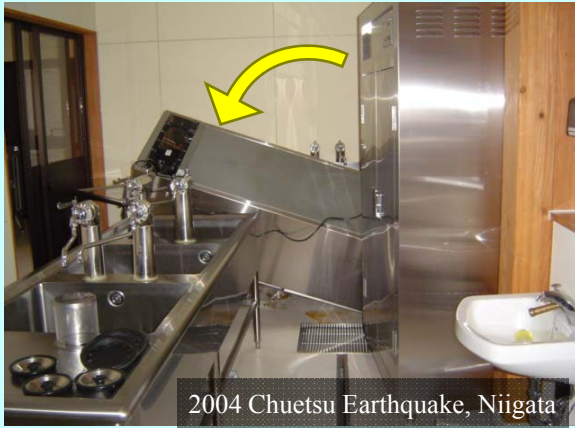
- Large kitchen refrigerator fell forward because of the seismic motion.

- Verify that the equipment is fixed to the floor with fixing brackets at the support base, and the top part is fixed to the wall.
- Verify that the fixing brackets are not rusted or degraded.
- Verify that fixing brackets are not loose.
- Install equipment on flat surfaces to restrict overturning.
- To store heavy items, store items in low positions to keep the center of gravity as low as possible.

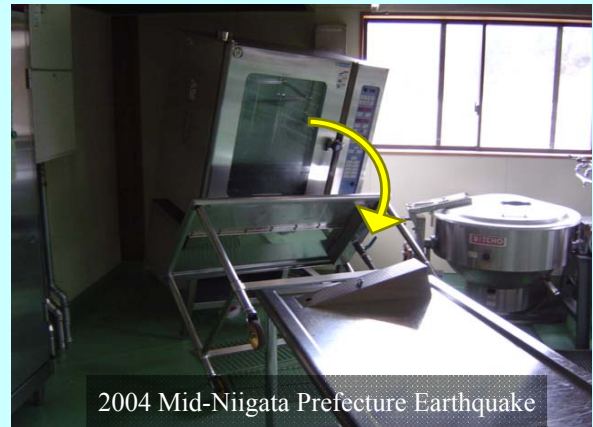
■ Overturned oven

- The seismic motion caused the large kitchen oven to moved forward, hit the trolley and tilt steeply.

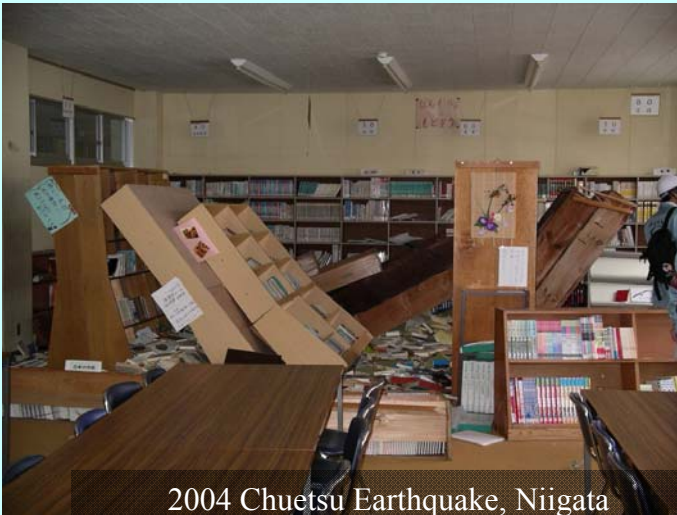
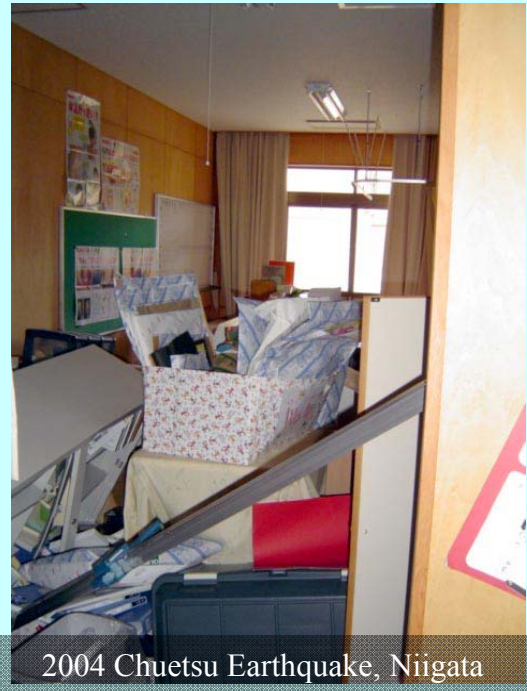
2004 Chuetsu Earthquake, Niigata

- Prevent overturning of bookshelves and lockers, and prevent contents from bursting out.
- Overturned bookshelves and lockers by the seismic motion. The contents burst out and were scattered over the floor.

- Fixing and securing bookshelves and lockers
- Fix bookshelves and lockers to sturdy wall, beam or ceiling with metal brackets.
- Interconnect the top of tall and shallow bookshelves.
- Bookshelves or lockers that are stacked should be fixed at the base and at the joint.
- Install a latch at the center of front opening doors.

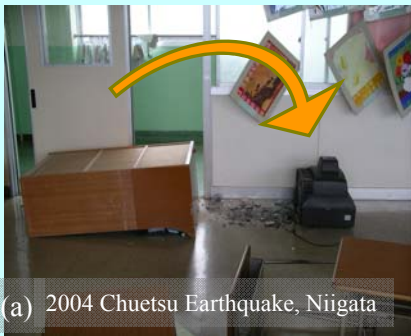
(a) 2004 Chuetsu Earthquake, Niigata

- Seismic motions caused the TV to skid off the hanging shelf. (See photo b)
- TV falling off hanging shelves could cause serious head injuries.
- Seismic motions caused desktop computers to fall off the desk.

- Verify that the mounting brackets of hanging shelves are secure and not loose.
- The TV should be securely fixed to the shelf with belts or other means to prevent it from skidding off (See photo d and e)

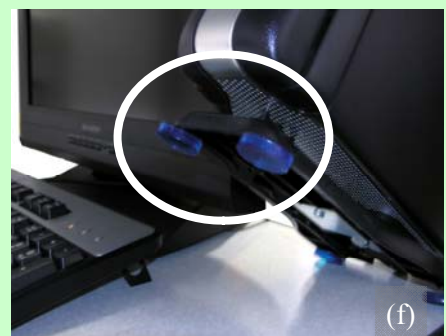
(f)

- To prevent desktop computers and displays from overturning, it is effective to secure their movement by using tie-down straps and self-adhesive cushion pad (Photo f).

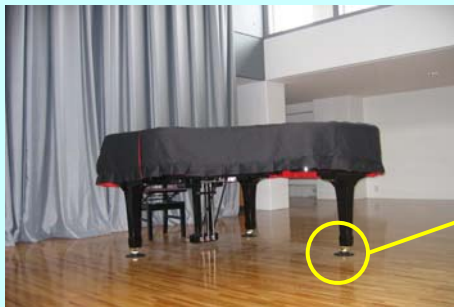
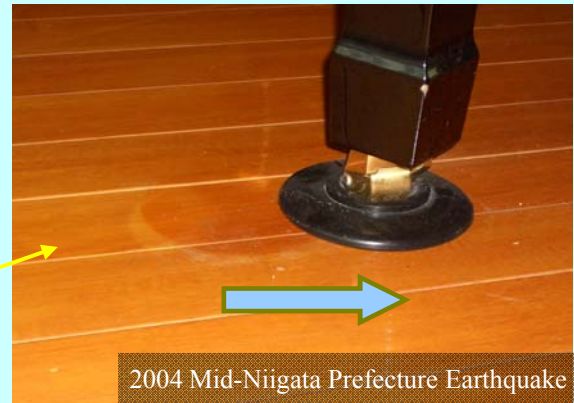
- The grand piano side slipped from the seismic motion.
- In this case, the wheel restrainer and the piano slipped together, and therefore, the movement was not significant. However, if the wheel restrainer failed, the piano could have slipped far greater distances.

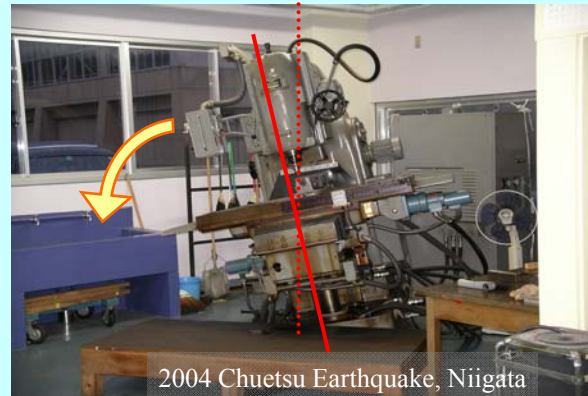
- Large machine tools used for training in a technical high school side slipped from the base and was overturned by the seismic motion.
- Machine tools were often not fixed to the floor and consequently sustained damages.

- Fix machine tools to the floor according to the manufacturer's specification (Photo a).
- When it is difficult to fix to the floor, increasing the base area, such as by using steel plates, is effective in preventing the machine from overturning (Photo b).
- Machine tools with relatively high center of gravity are prone to overturning, and therefore, the machine and its support frame (including the desk) should be fixed to the floor. Inspect that the mounting brackets are intact and not loose (Photos c and d).

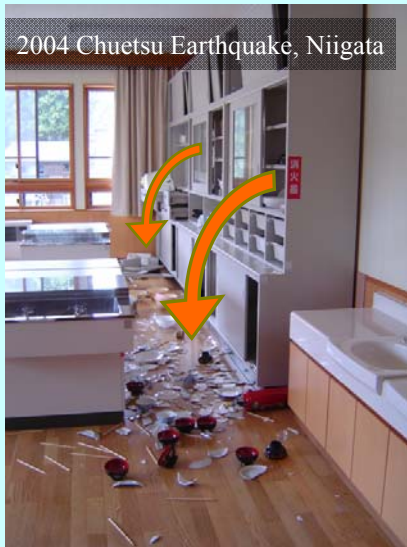
- The seismic motion opened the front doors of storage shelves and the dishes fell to the floor.

- Organize the contents of storage shelves.
- Do not place heavy objects on upper shelves.
- Verify that the front latches of storage shelves are not loose or rusted.

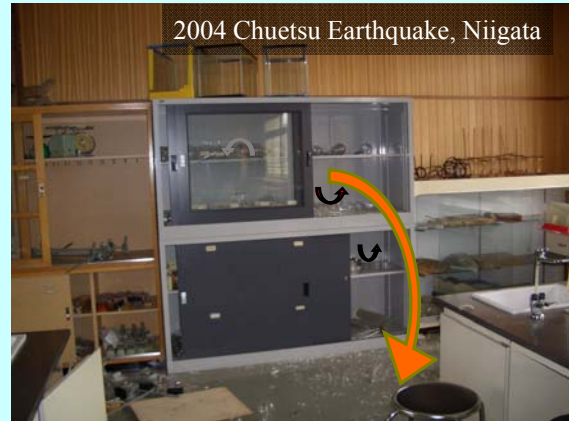
#### ■ Overturned lab equipment (Science classroom)

- The seismic motion opened the front doors of storage shelves, and the contents fell to the floor, destroying the lab equipment.

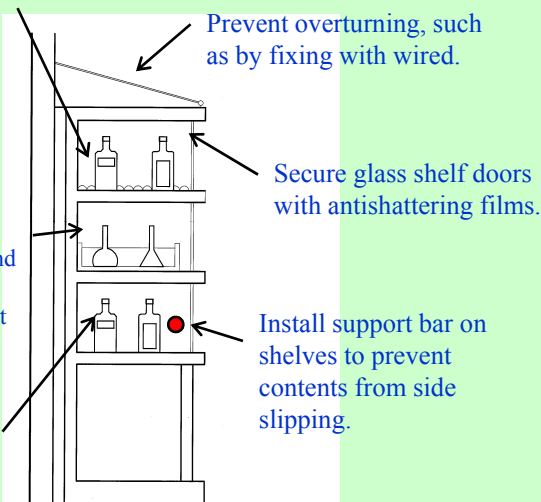
Replace glass containers with plastic ones as much as possible

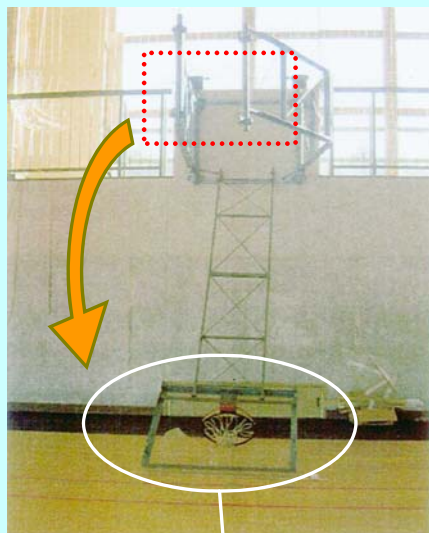
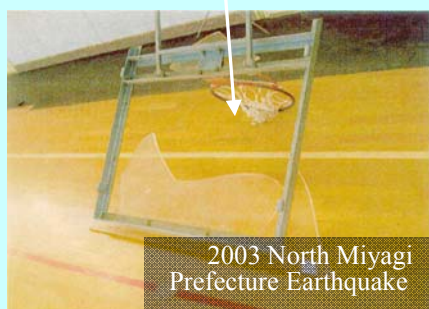
#### ■ Overturned and damaged basketball goal

- Seismic impact broke the support of the basketball goal and it fell to the floor.

- Verify that the mounting brackets and bolts are not loose or damaged.
- Verify that there is no rust or deterioration on mounting brackets.

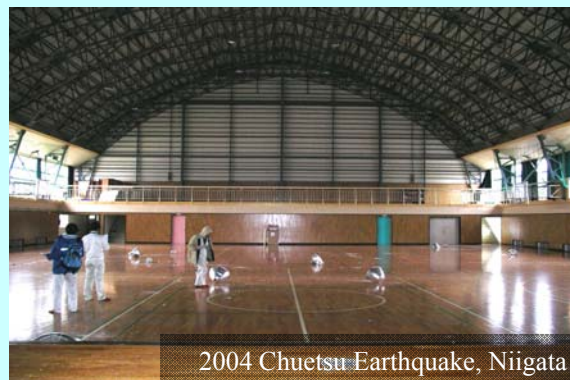
#### ■ Fallen gymnasium lights

- Many HID (high intensity discharge) lamps installed at the gymnasium ceiling have fallen.

- Verify that the mounting brackets of hanging lamps are not rusted.
- For arena lighting fixtures, verify the safety of mounting brackets for the hoist mechanism.

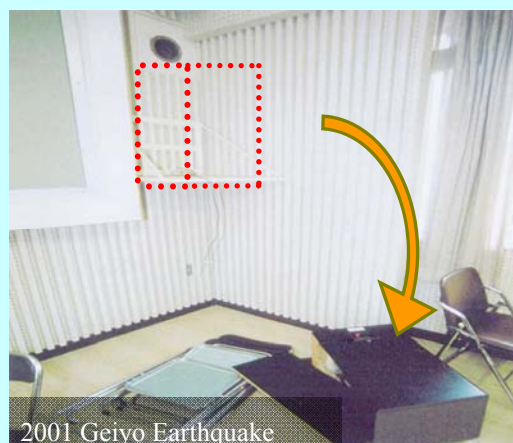
#### ■ Fallen loudspeaker

- Loudspeaker that was set by the wall, fell from the support frame onto the floor.

- Falling heavy objects, such as loudspeakers, could cause considerable damage. Therefore, these have to be securely fixed to the wall in at least two positions, at the top and bottom of the loudspeaker.

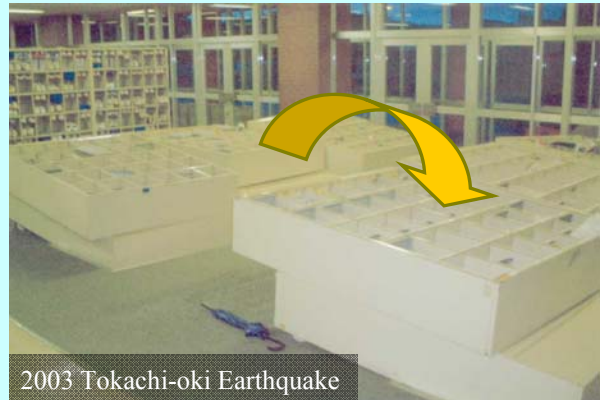
- The student shoe lockers at the entrance, which were set back-to-back, were overturned like dominos by the seismic motion.
- Overturned shoe lockers could block the evacuation route and obstruct evacuation after the earthquake.

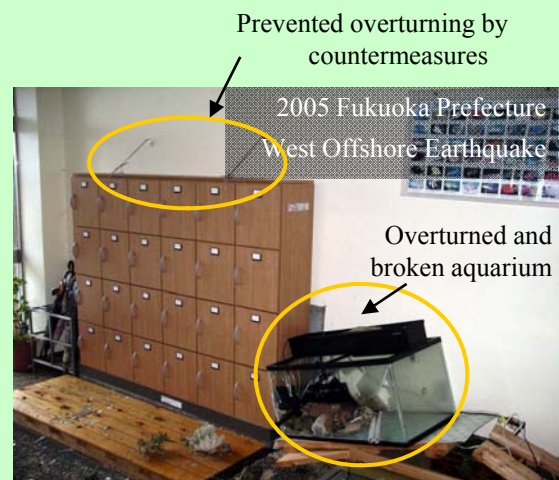
#### ■ Damaged aquarium

- When items set near the entrance, such as aquariums, topple and break, they could obstruct evacuation. Therefore, the support frame should be fixed with metal brackets. At the same time, to prevent the aquarium from side slipping, it should be fixed with support or wire, together with self-adhesive cushion sheets.
- When it is difficult to apply such measures, items that could obstruct evacuation should not be placed.

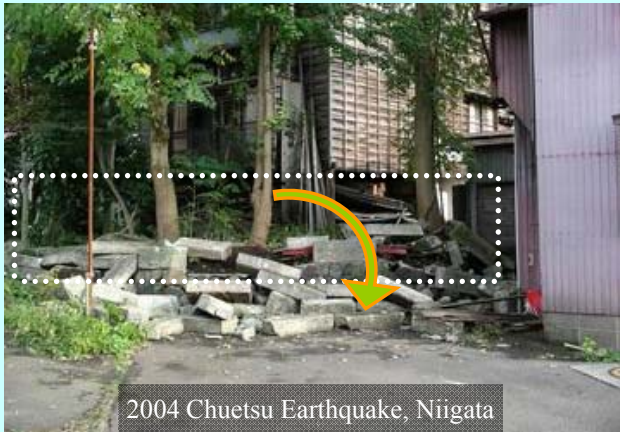
2004 Chuetsu Earthquake, Niigata

- Stone and concrete block walls were toppled and collapsed by strong seismic motions. Toppled or collapsed walls are frequently reported in other regions as well.

- Verify that the walls are not shaky, tilted, or unnecessarily high.
- Verify that the concrete block, masonry joint and steel rebars have not degraded or rusted.
- Verify that wall foundations are sufficiently embedded, and that the intervals between steel rebars, buttresses and stay posts are also sufficient.
- Verify that the heights of concrete block walls were not increased.

- Walls that are potentially dangerous should be rebuilt, or replaced with light fences, such as hedges or wire fence.
- Reinforce with buttresses or steel support frames (See right photo).

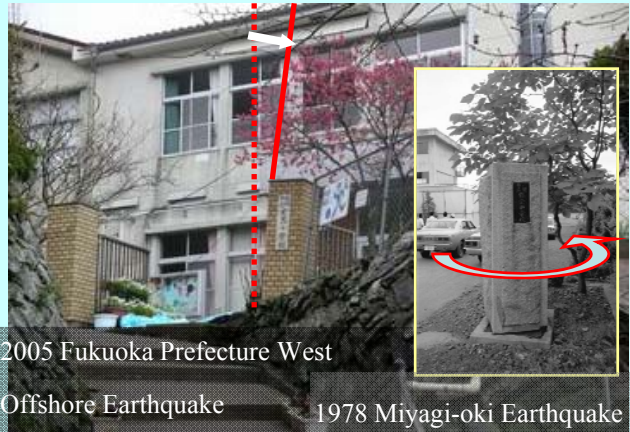
2005 Fukuoka Prefecture West

- Gatepost that tilted by ground deformation in a school that stood on sloping ground.
- On grounds that are not sloped, there were cases of gateposts that rotated at the base and those that have tilted or toppled because of liquefaction.

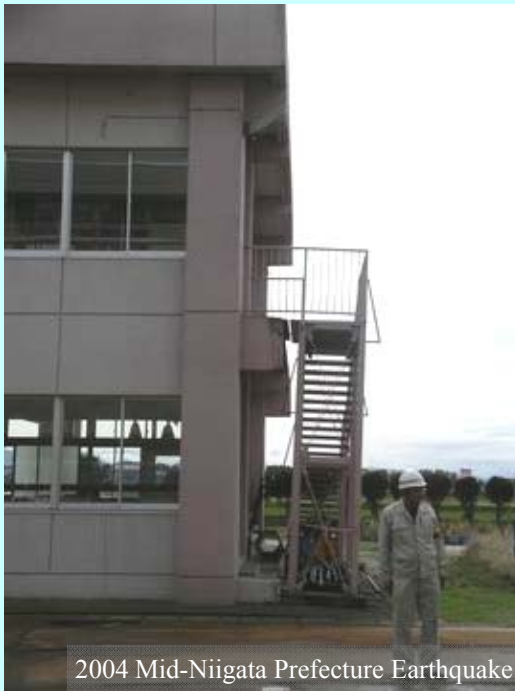
- The steel external staircase tilted from the foundation.

- Inspect and verify that the staircase is sufficiently and solidly joint to the structural frame, and that the staircase is structurally sufficient to support itself. The inspection and verification should be performed together with the seismic evaluation of school buildings and gymnasiums.
- Verify that staircases are not shaky and that the anchor bolts have not degraded. It should be noted that, walls that protrude or placed far from floor slabs or staircases, or walls that have no support members are prone to seismic motions.

- When cracks occur on staircases and walls, or when they tilt after earthquakes, they are at risk of overturning or falling. Therefore, these facilities should be prevented from being used, and considering their effects, entrance to nearby areas should be restricted.

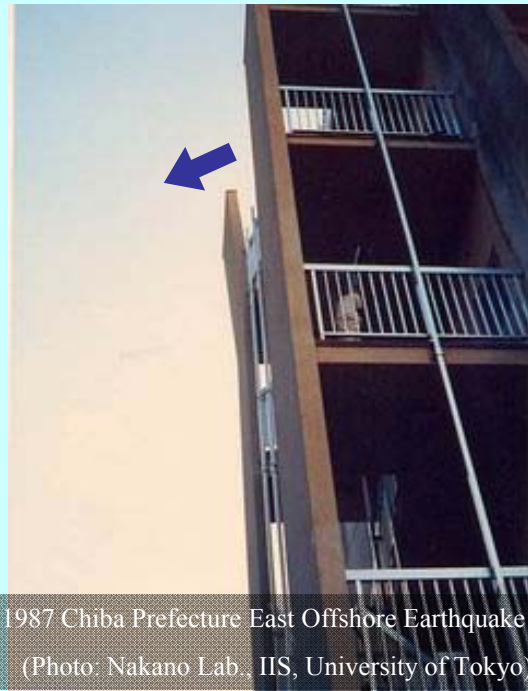
#### ■ Tilted reinforced concrete wall of the external staircase

- The exterior wall of the staircase was damaged and tilted outward.
- There are risks that these could collapse and fall from the aftershock.

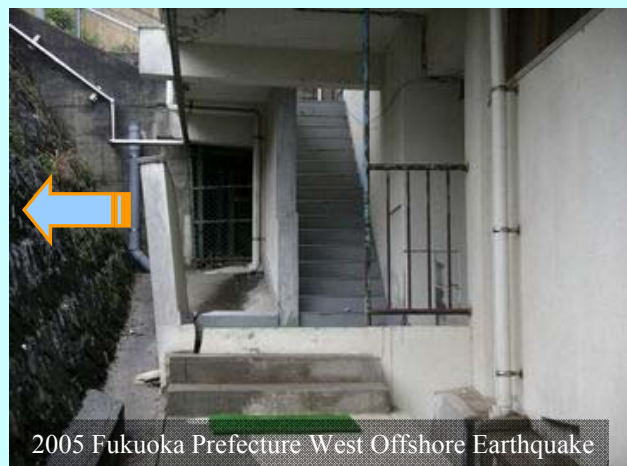
#### ■ Tilted reinforced concrete wall of a staircase

- The staircase wall of a gymnasium, which was built on a sloped ground, was damaged and became tilted.
- This appears to be caused by the effect of cracks at the staircase floor from ground deformation. Heavy reinforced concrete walls could easily tilt or topple, once they are damaged by seismic motions (See right photo).

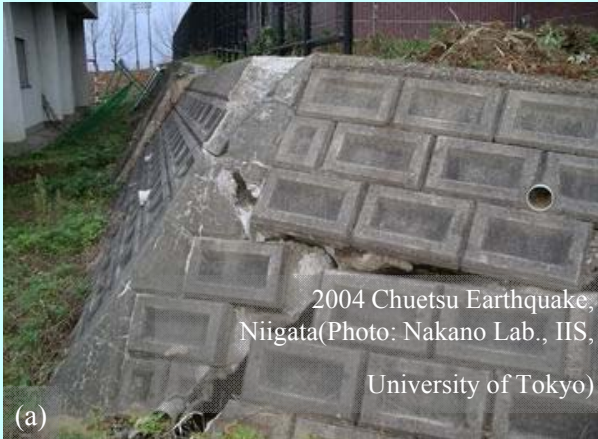
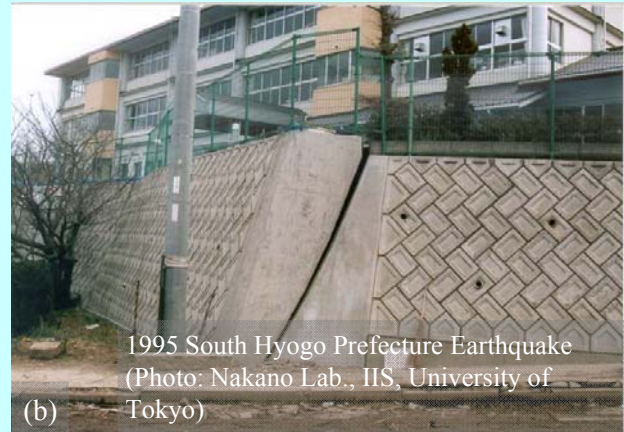
#### ■ Damages on retaining wall

- Significant damage to retaining walls, such as the settlement of surrounding grounds, buckling or cracking that accompanies ground deformation on sloped or developed grounds have occurred frequently (Photo a).
- Shifting of retaining walls, even those that are relatively new, have been observed (Photo b).

- Verify that there are no cracks or buckling of retaining wall
- When the building stands directly above or below a steep slope, and when people or vehicles travel such areas, the safety of the ground and retaining walls against earthquakes should be studied by an expert.

- When cracks or shifting of retaining walls are confirmed after an earthquake, the fact that the retaining walls are at risk of failing or tumbling should be clearly indicated at inside and outside the school. It is necessary to restrict passers-by immediately, and notify the danger to students and public who may pass near the retaining wall.

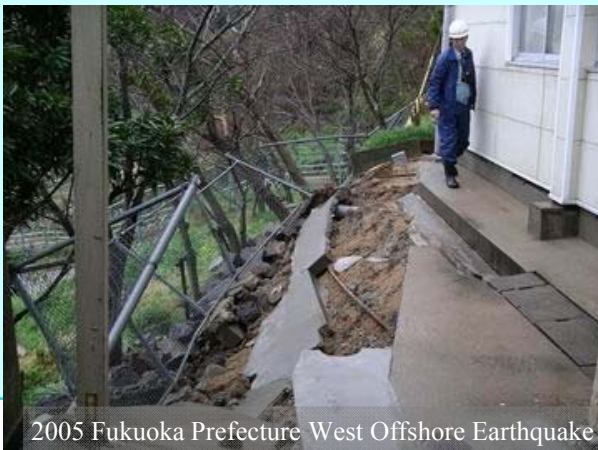
#### ■ School ground that collapsed together with the cliff

- School ground, which stands on sloping ground that collapsed with deformation of the ground.

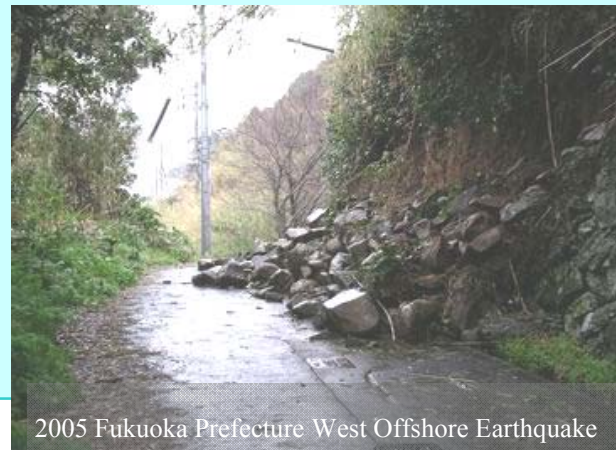
#### ■ School commuting route that was affected by the slope failure.

- The school commuting route was blocked as the slope in the mountainous region failed.

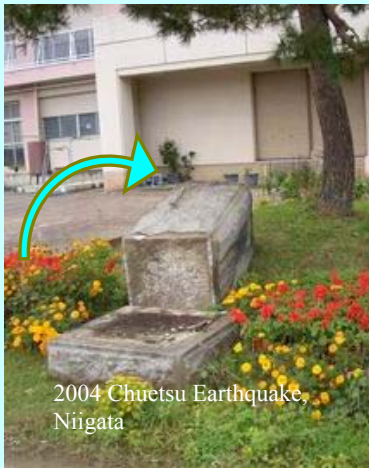
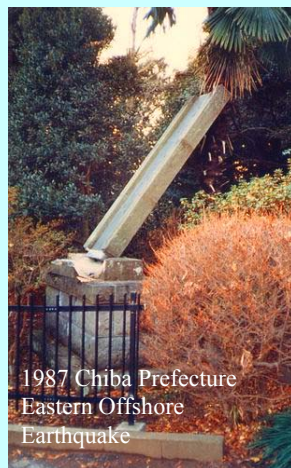
- Monuments and statues in the school ground were overturned by earthquakes.
- There was a case in the past, where a stone lantern in a shrine was overturned and caused casualty. (1987 Chiba Prefecture Eastern Offshore Earthquake)

- Inspect inside and outside of buildings to see that there are no timber and long or wide stone plaques propped up against the building wall.
- Verify that monuments are not shaky and that their foundations are sufficiently embedded.

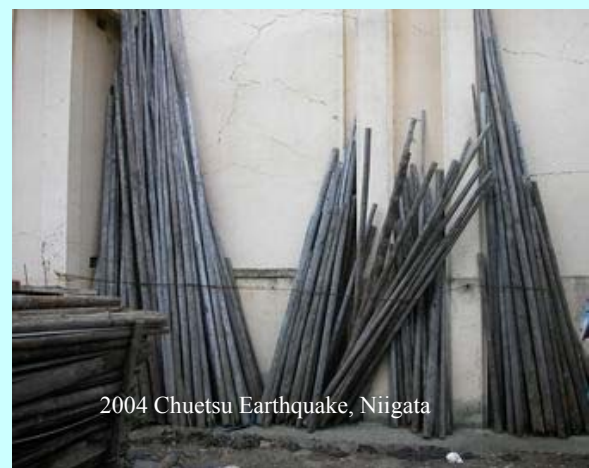
### ■ Overturned snow fence material

- Timber for snow fences that were propped up against the school building have toppled.
- Those that had been restrained by wires did not topple significantly.

- Implement measures to prevent timber and other material from collapsing. Then, they should be either piled flat, or restrained from toppling with wire, chain or rope.
- Verify that the restraining wire, chain and rope are of sufficient length (or height) and strength, considering the weight of the material. Then, the materials should not be tied loose and restrained by giving sufficient consideration to the lengths of the material.
- Heavy objects such as stone plaque or monuments should have their foundations sufficiently embedded or sufficiently reinforced to prevent them from toppling at the base.
